## M300 RTK Known Issue List

### M300 RTK Released Version In This List

Released Date :	2021.10.13
Aircraft Firmware :	v03.00.01.01
Remote Controller Firmware :	v03.00.01.02
Pilot App Android :	V3.0.1.4 (M300)
D-RTK 2 Mobile Station for Matrice :	v03.00.00.16 (D-RTK 2 Mobile Station: v02.02.0505)
Intelligent Battery Station :	v03.00.01.01
Intelligent Flight Battery :	v01.02.05.31
Zenmuse H20/H20T :	v03.00.01.02
Zenmuse P1 :	v03.00.01.04
Zenmuse L1 :	v03.00.02.00
Zenmuse Z30 :	v01.00.07.10
Zenmuse XT2 :	v01.00.03.50
Zenmuse XT S :	v01.00.00.09
DJI X-Port :	v01.03.02.00
DJI Skyport :	v01.04.00.00
DJI Skyport V2 :	v01.03.02.00
DJI Assistant 2 (Enterprise Series) :	v2.1.2

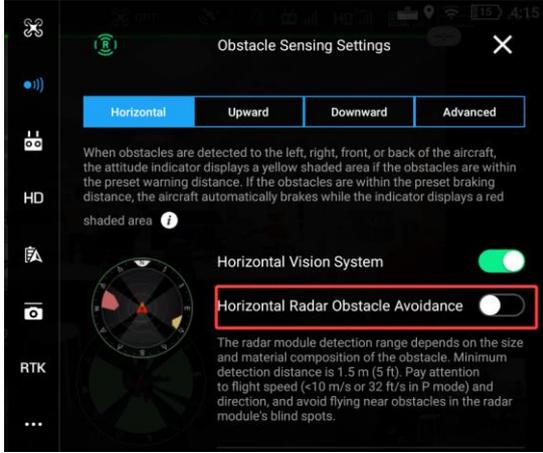
5	When CSM Radar is removed from Aircraft and continue to execute the Manual Flight or Mission Flight, the remote controller makes a beeping obstacle avoidance sound however there	Re-install the CSM Radar on the aircraft Open the Pilot APP, Go into the Manual Flight Find [Obstacle Sensing setting] Go into [Horizontal] page Click the [Horizontal Radar Obstacle Avoidance] off

<p>is no obstacle around.</p>	<p>Restart the flight, the alarm is settled down.</p>

<p>It will be optimized in the later verison.</p>
-------------------------------	--

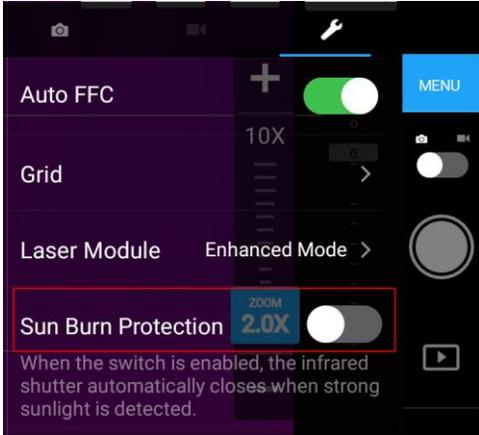
1.	<p>When H20T is aimed at an object with a high temperature, the Sun Burn Protection function may be triggered, and there will be an option to allow you to disable the protection. However, after you disable it, later the Protection will still be triggered.</p>	<p>Please disable the Sun Burn Protection function in the camera setting page.</p>
